FINAL REPORT OF SPECIFIC PURPOSE LIDAR SURVEY

LiDAR, Breaklines and Contours for Gulf County, Florida

State of Florida
Division of Emergency Management
Contract 07-HS-34-14-00-22-469
Task Order 20070525-492718a
PDS Task Order B

**Final Report of Specific Purpose LiDAR Survey, including
LiDAR-Generated Breaklines and Contours for Gulf County, Florida
Contract 07-HS-34-14-00-22-469; T.O. No. 20070525-492718a, Task Order B**

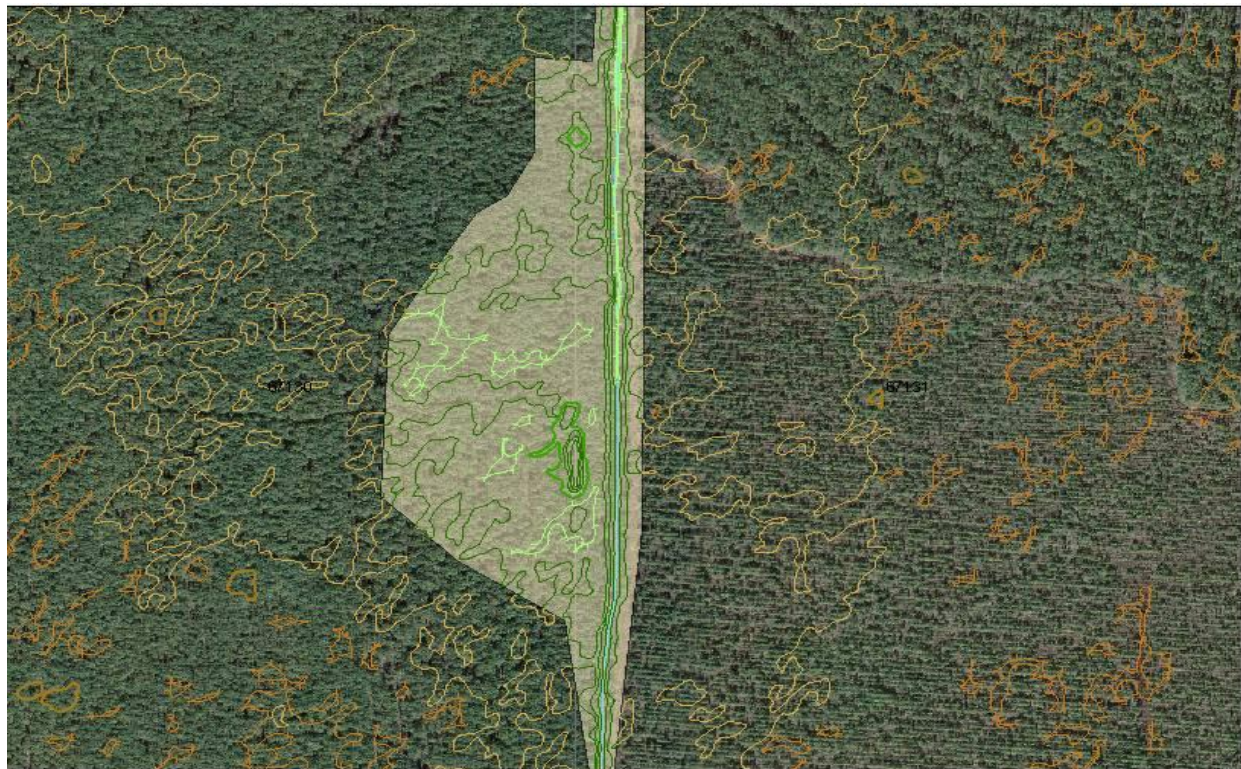
The apparent boundary of vegetated areas (1/2 acre or larger) that are considered obscured to the extent that adequate vertical data cannot be clearly determined to accurately define the DTM are correctly captured as two-dimensional features with no z-values. Figure 8 shows example breaklines and contours for low confidence areas.
